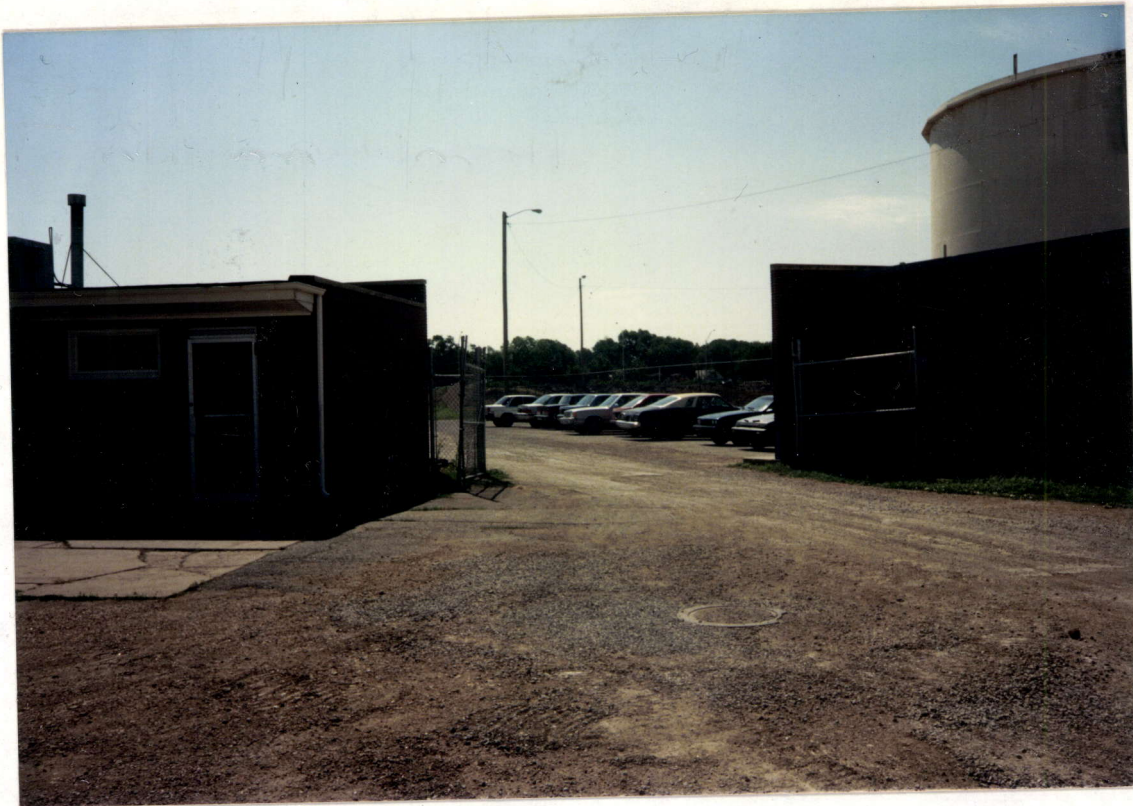
Film Roll No.: 1 Date: 6/19/90 Time: 1000
 Exposure No.: 11 Photographer: JPN
 VSI Observations: Entrance to HRI facility with Bldg. A on the right.
 View - SE

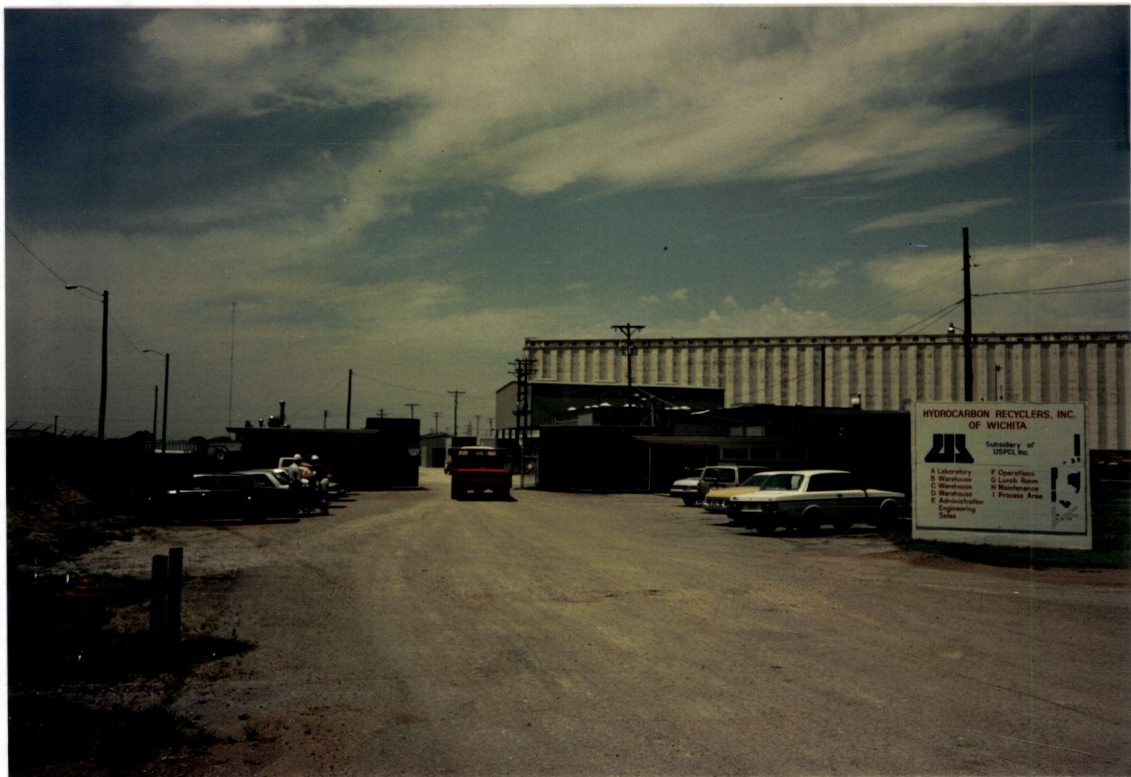
Film Roll No.: 2 Date: 6/19/90 Time: 1315
 Exposure No.: 5 Photographer: JPN
 VSI Observations: Entrance to HRI facility. View - W

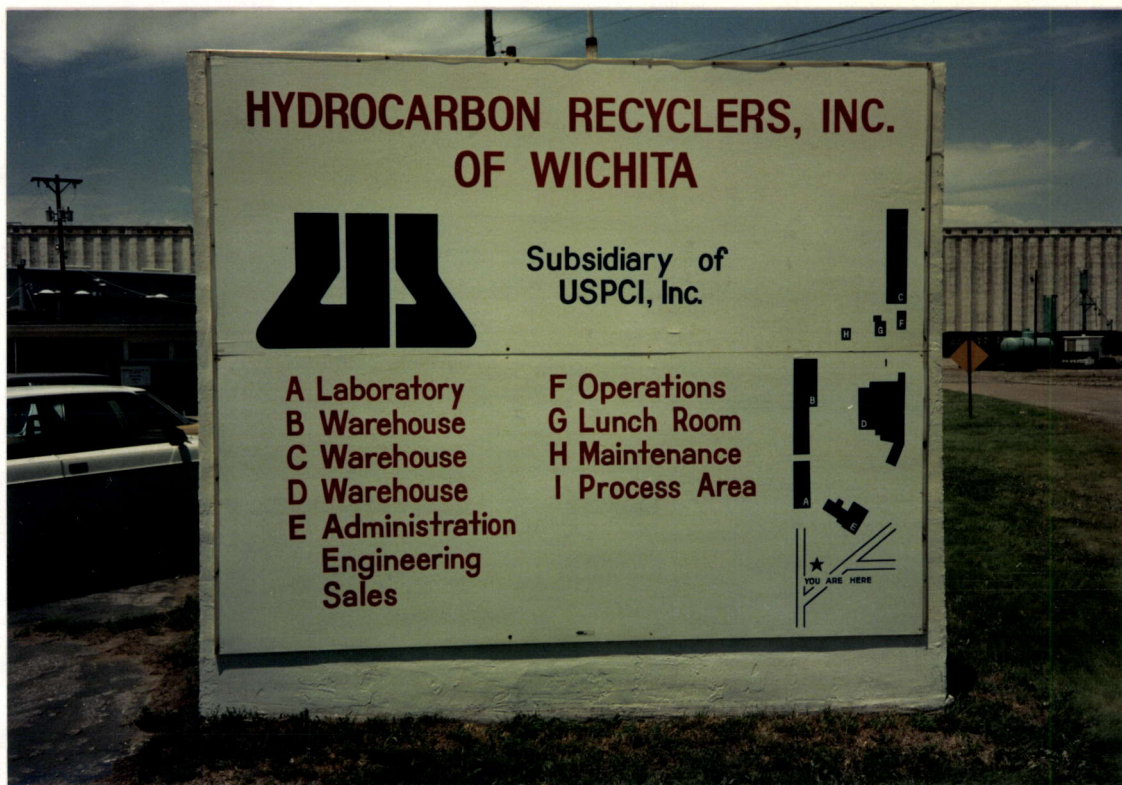
Film Roll No.: 2 Date: 6/19/90 Time: 1315
 Exposure No.: 6 Photographer: JPN
 VSI Observations: HRI facility sign. View - NW

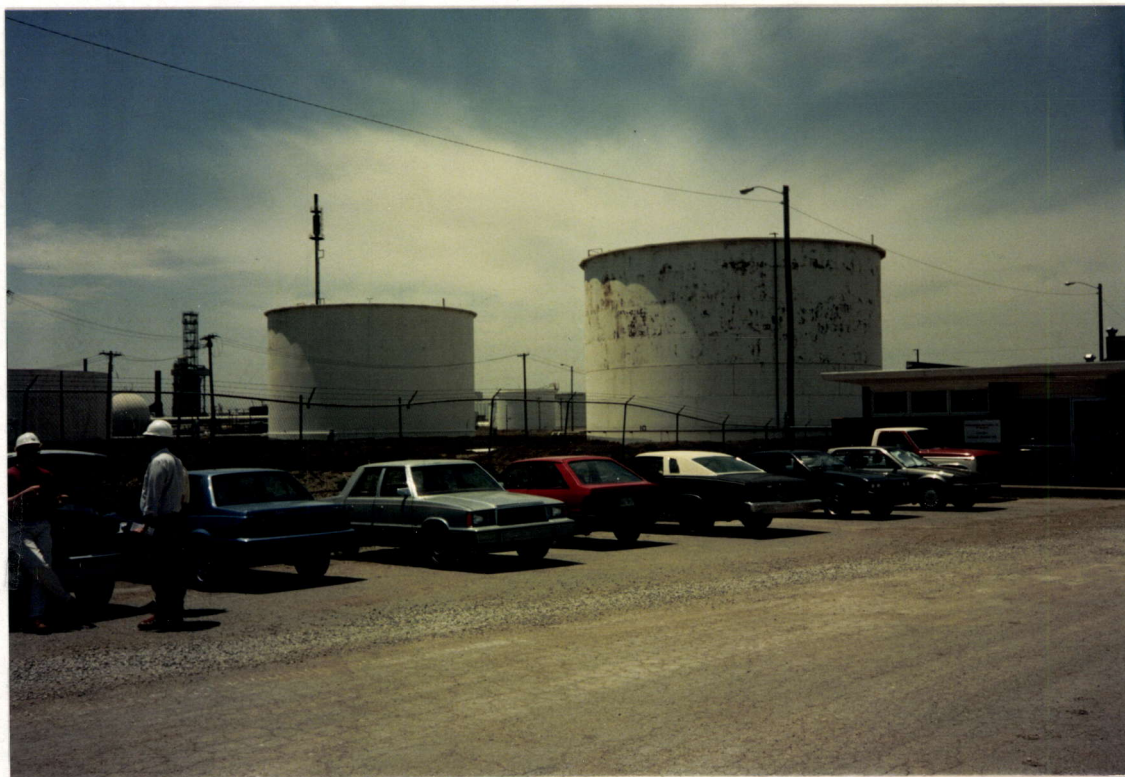
Film Roll No.: 2 Date: 6/19/90 Time: 1316
 Exposure No.: 7 Photographer: JPN
 VSI Observations: Derby Refinery property, south & west of HRI property.
 View - SW

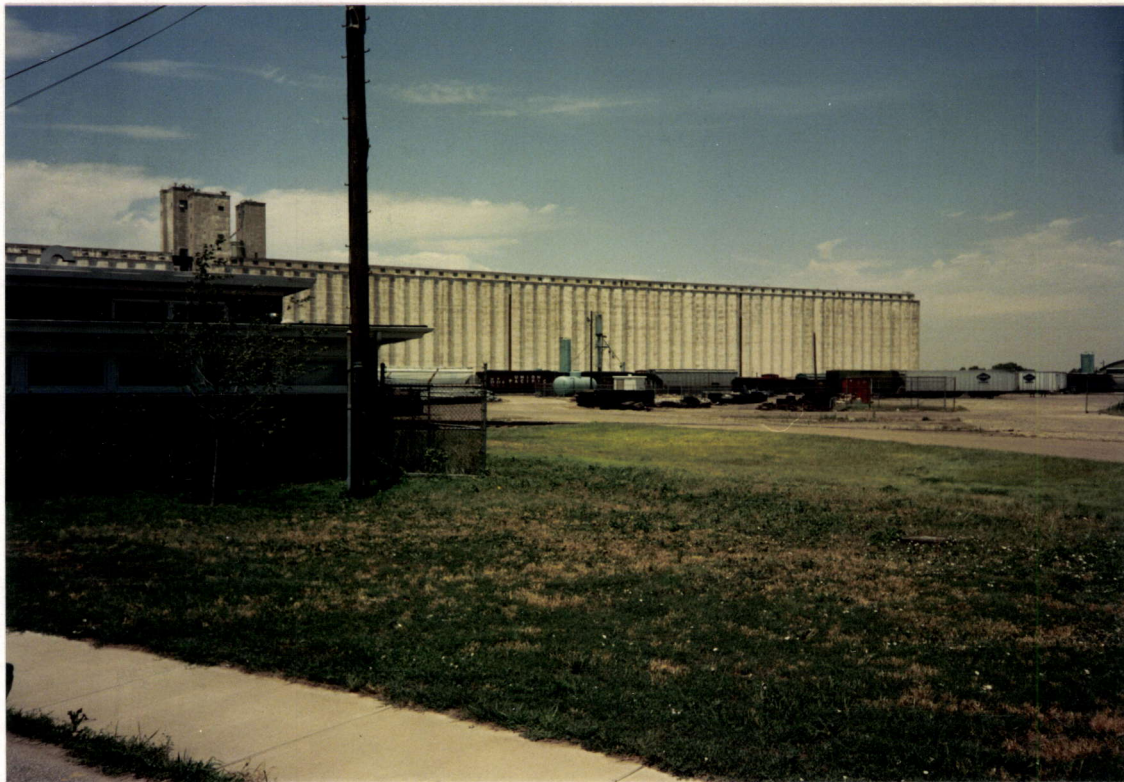
Film Roll No.: 2 Date: 6/19/90 Time: 1316
 Exposure No.: 8 Photographer: JPN
 VSI Observations: Union Pacific Railroad property, north of HRI property.
 View - NW
